Campus Development Plan

2023 – 2032

EXECUTIVE SUMMARY

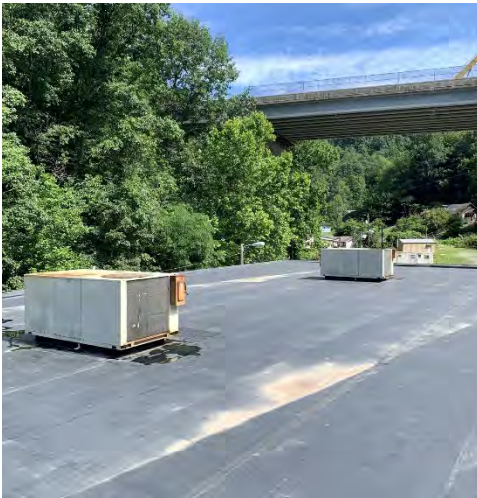
Rooftop HVAC Units

This building is heated and cooled with a combination of rooftop air handling units, split dx systems, exterior wall unit ventilators and water-source heat pump units throughout the building. The rooftop units have dx-cooling coils and gas-fired heating coils. A Baltimore Air Coil cooling tower conditions the water for the water-source heat pump loop, and the pumps for the heat pump loop are in the adjacent Mechanical Room. The heat pump loop system is leaking and requires makeup water on a regular basis. Most of the equipment has reached and exceeded the end of its service life. As heat pump units have failed, the maintenance staff has replaced them with similar units. Outside contractor performs water testing and chemical management of cooling tower and condenser loop water. Maintenance is performed by Logan Campus personnel.

Most of the building does not have ventilation air. Only the exterior wall unit ventilators and the rooftop units provide ventilation air. The building automation system (BAS) is from Trane, and only controls the rooftop unit serving the Theater and three rooftop units serving the upstairs. There is no standardization to the controls – there are thermostats from at least six different manufacturers throughout the building. All of the roof mounted equipment shows signs of corrosion, and most of the ductwork exposed on the roof has insulation that is either damaged or covered in mold.

5. A new HVAC system is needed that will replace the current equipment and provide ventilation air to all spaces: cooling would include the addition of a second air cooled chiller on the pad next to Building B in order to have a central chilled water system for the entire campus; heating would include the addition of high efficiency hot water boilers; airside systems would consist of variable volume air handling units with VAV boxes for individual spaces.

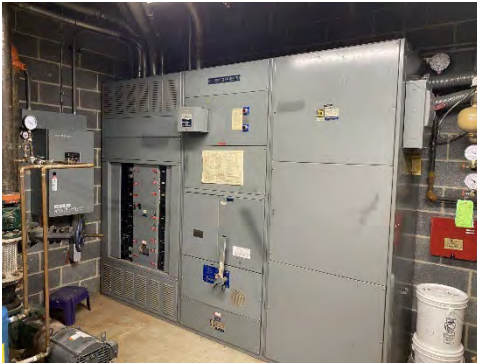
Electrical Power System MDP

The electrical service for the building is fed underground via a pad mounted transformer to the service meter located in the main electrical room. With the moving of the TV station to the Williamson campus the overall electrical load has been lightened. The electric service is 1200 amps which appears adequate for the buildings need. Some panels that have had loads removed do not have updated panel schedules and taped covers were breakers are removed. The MDP (Main distribution panel) was rebuilt after an internal electrical fire caused by the old service transformer two years ago. The MDP is in fair condition with no notable damage. In

the modular classroom the power poles that are utilized in some of these locations are falling apart making them unsafe.

15. Install weather covers on all exterior receptacles.
16. Replace all power poles with new a dual channeled portable power poles for both data and electric connections.

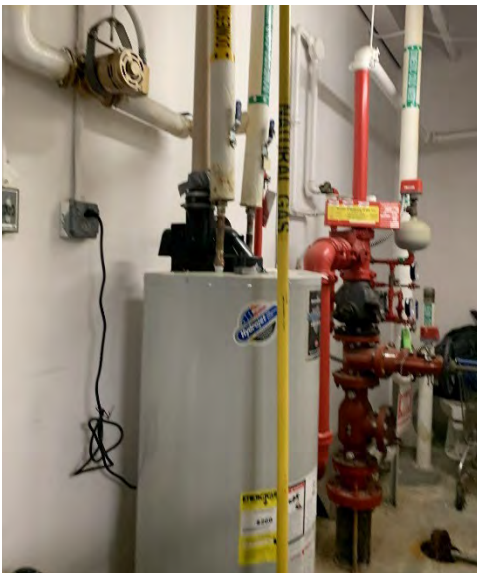
Water Heater / Sprinkler System Entrance

The main water service to the building was not provided with a backflow preventer. There was a central, gas-fired, power vent A.O. Smith water heater that was not provided with an expansion tank or a thermostatic mixing valve. Recirculation piping and pump were provided, all domestic water piping and equipment appeared operational and in good condition. ADA compliant toilet rooms were provided on each floor, all toilet rooms contained flush valve type fixtures. All fixtures appeared operational and in good condition. A mop basin was provided in the mechanical room.

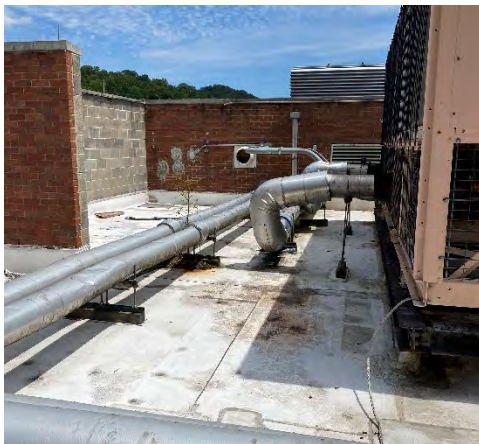
Roof needs replacement.

The existing roofing is EPDM and is in poor condition. It has been covered with a coating that is currently peeling. Many flashings and joints are cracked and are allowing water infiltration. There is evidence of ponding water in a few locations and there are some areas that require emergency overflow drains. It is expected that some of this water infiltration will result in some metal roof decking at the southern addition and library addition will be required to be replaced. This should be considered when the building is reroofed.

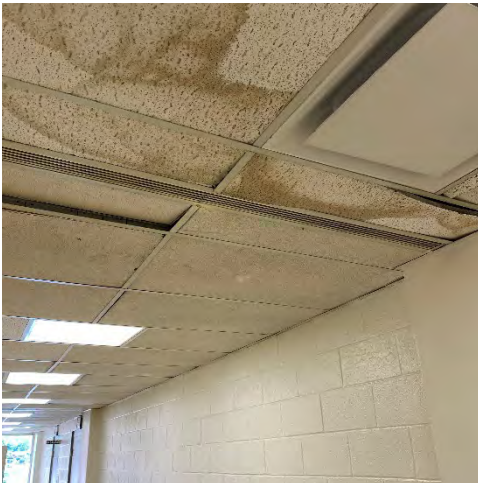
Most spaces are separated by CMU walls and minimal gypsum board partitions. Ceilings are typically suspended acoustical ceiling tile. Most ceiling tiles are stained from roof leaks. Flooring is mostly VCT and porcelain tile in entryways and first floor corridors, and ceramic mosaic tile in restrooms. The restrooms adjacent to the elevator on the first three floors were renovated in 2021. The college has been actively painting and installing new flooring in most of the corridors over the last couple of years.

Stained Ceiling Tiles

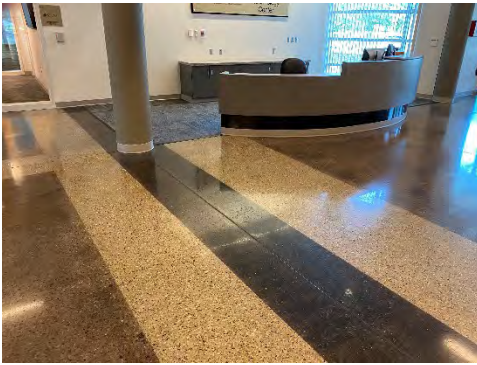
The ground floor is a concrete slab on grade. Some minor cracks were observed in the concrete slab. There were some signs of water infiltration at the garage doors in the large assembly area. The loads applied to the floors appear to be consistent with typical educational and administrative loadings. The roof structure consists of open web steel bar joists with metal decking. The building structure falls under a seismic design category B. The building has been designed to withstand seismic loads according to the applicable building code during design and construction.

Stained Concrete Floors

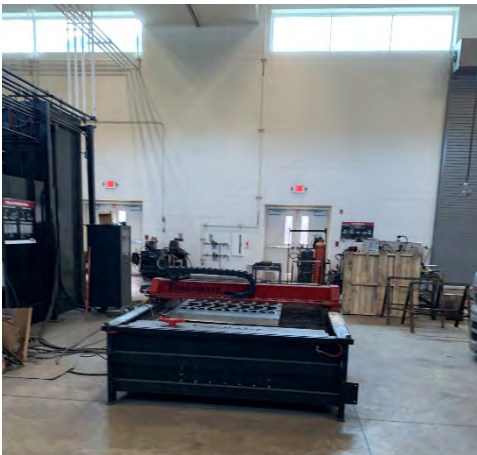
Plasma Cutter Needs an Exhaust Hood

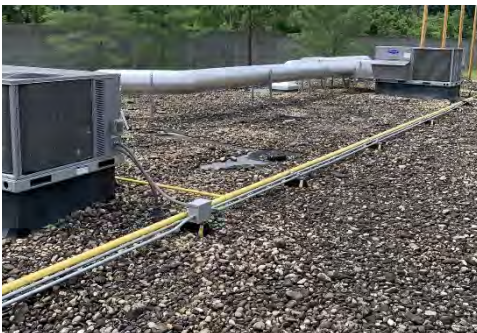
Roof Needs to be Replaced

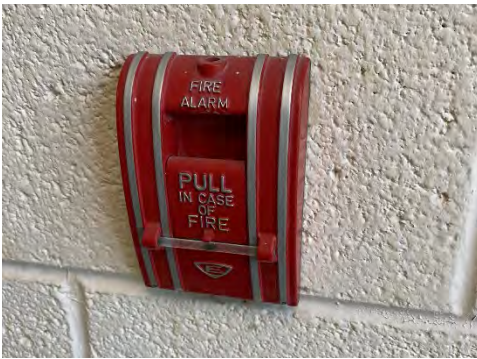
Fire Alarm Pull – Not ADA Height

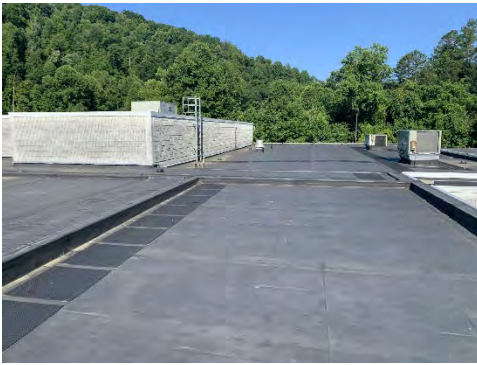
EPDM Roofing

The existing roofing is EPDM and is in good shape however will be nearing the end of its life by the end of this 10-year period. There is minimal evidence of ponding water in a few locations.
