Campus Development Plan

2023 – 2032

EXECUTIVE SUMMARY

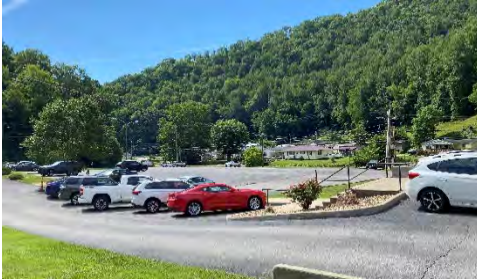
Main Parking Lot

As noted above, there are several parking areas. The most prominent parking area is the large parking lot that connects the three facilities. This parking lot has been recently paved in 2022. This main parking area need to be redesigned to include landscaping, pedestrian circulation, and separated visitor, staff, and student parking. Site lighting, security cameras, and security call stations (blue-phones) should be included in the revised layout. The improvement of this area would be a cost-effective way to improve the overall image of the campus.

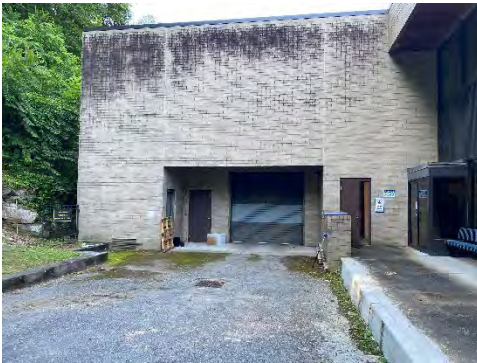
Loading Dock at Stage Workshop

The exterior envelope is in good condition. The exterior walls are comprised of brick veneer, metal wall panels, and punched windows around the building. The brick at the rear of the building around the loading dock is stained and could benefit from a cleaning.

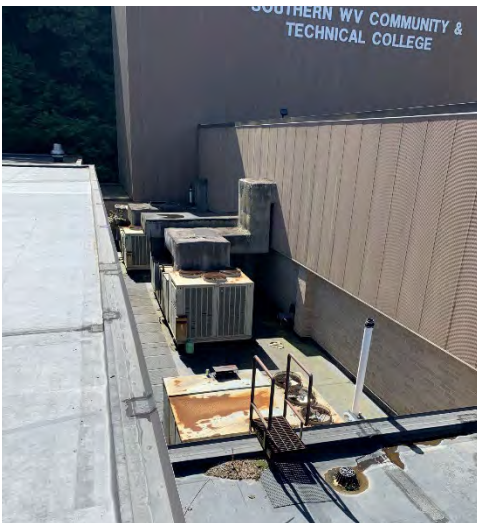
Roof ‘Well’ at Auditorium HVAC units

The existing roofing is EPDM and is in good shape. There is minimal evidence of ponding water in a few locations however there are some areas that require emergency overflow drains. This should be considered when the building is reroofed. The ‘well’ area where the auditorium units are located may require to be reroofed prior to the remainder of the roofing. If these HVAC units are replaced, it is recommended this roof be replaced at the same time. The hip roof at the front of the building is metal roofing and appears to be in good condition.

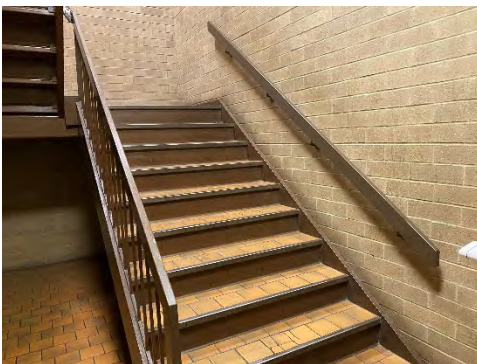
Stairs

Circulation between the levels is through elevators or perimeter stairwells. These stairs have quarry tile on the treads and painted steel pans. The existing handrails meet current existing codes, however if the building undergoes significant renovations, these handrails will need to be modified to meet current codes. The stairs doors have panic exit hardware however these should be upgraded and have been repaired. The elevator cab does not have controls meeting current codes and should be upgraded to accommodate fire fighter controls.

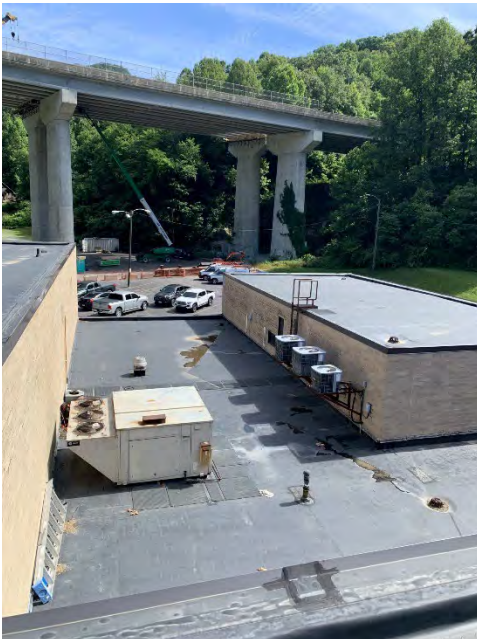
Rooftop HVAC Units

This building is heated and cooled with a combination of rooftop air handling units, split dx systems, exterior wall unit ventilators and water-source heat pump units throughout the building. The rooftop units have dx-cooling coils and gas-fired heating coils. A Baltimore Air Coil cooling tower conditions the water for the water-source heat pump loop, and the pumps for the heat pump loop are in the adjacent Mechanical Room. The heat pump loop system is leaking and requires makeup water on a regular basis. Most of the equipment has reached and exceeded the end of its service life. As heat pump units have failed, the maintenance staff has replaced them with similar units. Outside contractor performs water testing and chemical management of cooling tower and condenser loop water. Maintenance is performed by Logan Campus personnel.

Most of the building does not have ventilation air. Only the exterior wall unit ventilators and the rooftop units provide ventilation air. The building automation system (BAS) is from Trane, and only controls the rooftop unit serving the Theater and three rooftop units serving the upstairs. There is no standardization to the controls – there are thermostats from at least six different manufacturers throughout the building. All of the roof mounted equipment shows signs of corrosion, and most of the ductwork exposed on the roof has insulation that is either damaged or covered in mold.

5. A new HVAC system is needed that will replace the current equipment and provide ventilation air to all spaces: cooling would include the addition of a second air cooled chiller on the pad next to Building B in order to have a central chilled water system for the entire campus; heating would include the addition of high efficiency hot water boilers; airside systems would consist of variable volume air handling units with VAV boxes for individual spaces.

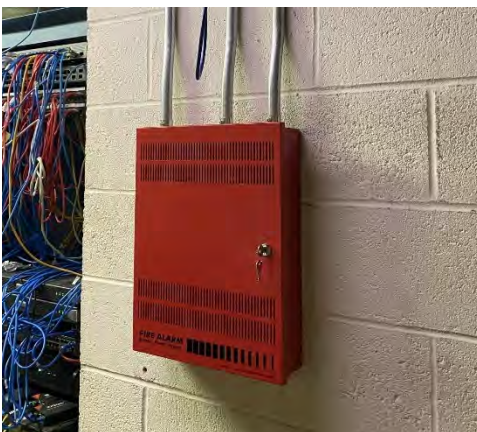
Fire Alarm Control Panel

All the campuses fire alarm systems are tied into one main fire alarm control panel located on the first-floor corridor wall of Building A. The fire alarm control panel is a modern Edwards iO Series with on-board battery backup. The fire alarm system was replaced in 2021. The Computer Center room, located on the first floor, uses a dry fire suppression system. All emergency lighting and the data center are on a Kohler 80kW, 3 phase, 480/277V natural gas generator. The elevator does not have backup power. The exit signs throughout the building are older incandescent lamp style with green or red laminated lenses.

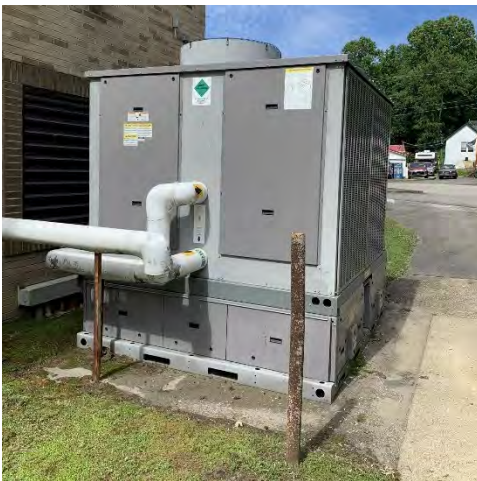
The HVAC system consists of a central Carrier 50-ton Chiller and Carrier Variable Air Volume (VAV) Air Handling Unit (AHU) with a chilled water coil and a hot water heating coil. The chiller is located directly outside the mechanical room. The AHU and Chiller are of the 2018 vintage. There is a return air fan drawing from return air from the ceiling plenums on each of the two (2) floors. Everything within the return air plenum appeared to be plenum rated and code compliant. There are zone level VAV boxes with hot water reheat coils. There is one Lochinvar Copper Fin boilers and two (2) base-mounted TACO pumps located in the mechanical room for the AHU heat coil and VAV reheat coils. The heating hot water contains glycol and has an appropriate glycol feeder.

Sufficient fresh, outdoor ventilation air is provided to the AHU through a louver in the mechanical room. Proper exhaust air was provided to all toilet rooms. All ductwork and hot water piping is provided with external insulation and appeared to be in good condition. There were only a few areas of the building that appeared to be fire-rated as the wall penetrations were fire-caulked, no fire dampers in the ductwork were observed or appeared to be needed. There is a Carrier central Building Automation System (BAS) of the same vintage as the AHU and chiller. Maintenance for the mechanical system is performed by the Logan Campus personnel.

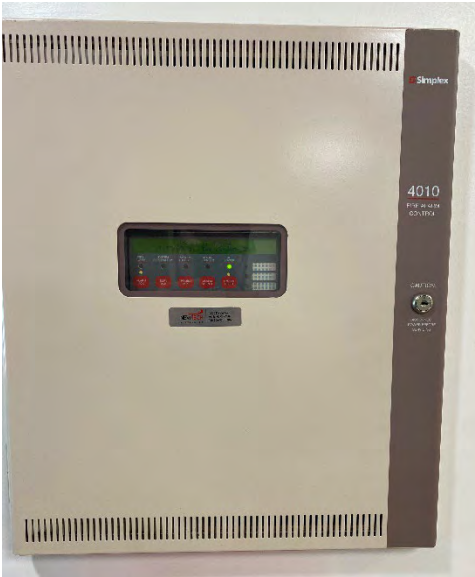
Fire Alarm Control Panel

The building has a complete, code compliant fire protections system with all appropriate valves, sensors, and flow meters. Information was not attained on any recent testing. There were no issues observed or reported with the fire protection system.

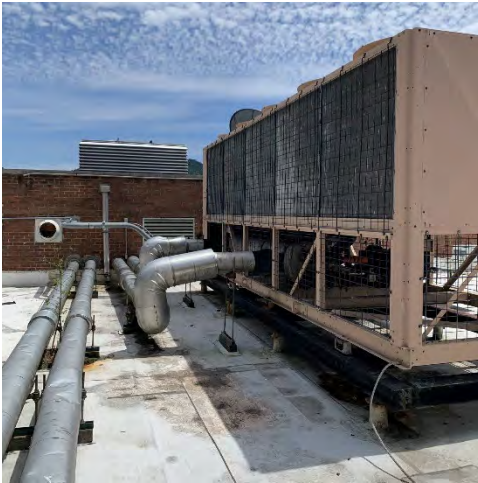
Chiller

The chiller, boilers, hot water pumps and air handling units AHU-4, -5, -6 and -7 were replaced in 2003. At that time a new Building Automation System (BAS) from RDS Controls was installed as well. Most of the ceiling tiles throughout the building show signs of cupping, which typically indicates humidity control concerns. The Library AHU is very loud and transmit noise to the adjacent spaces. Sound attenuation measures should be added to this unit and/or room to limit the noise transmitted through the Mechanical Room walls.

9. The HVAC systems needs to be replaced to address the numerous heating issues throughout the building, ensure the building is properly ventilated, and ensure building relative humidity is properly controlled.

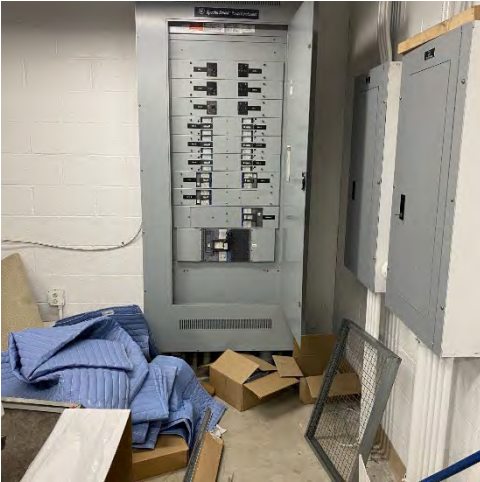
Electrical Power Systems - MDP

The electrical service for the building is fed underground via a pad mounted transformer. The overall condition of the MDP (Main distribution panel) is in fair condition with no notable damage. The janitor's closet, room 211 has a recessed style electrical panel that is installed as a surface mount. The panel has open punch outs on the top and the buss bars is exposed. The data closet on the first floor has a panel with large gage exposed wire having bare ends. This room also has storage placed in front of the electrical panels.

21. Replace damaged panels and wiring.
22. Remove all unused and damaged electrical power runs and receptacles.
23. Create necessary spacing around all electrical panels per NEC.

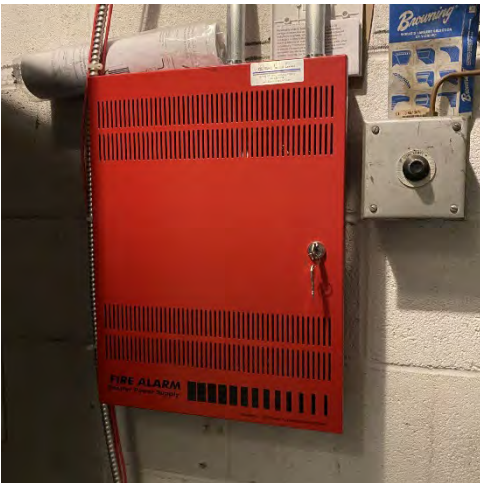
Fire Alarm Control Panel

The fire alarm control panel is a modern Edwards iO Series with on-board battery backup. The fire alarm system was replaced in 2021. The FACP is located just outside of the library, mounted on the wall in the corridor on the first floor.

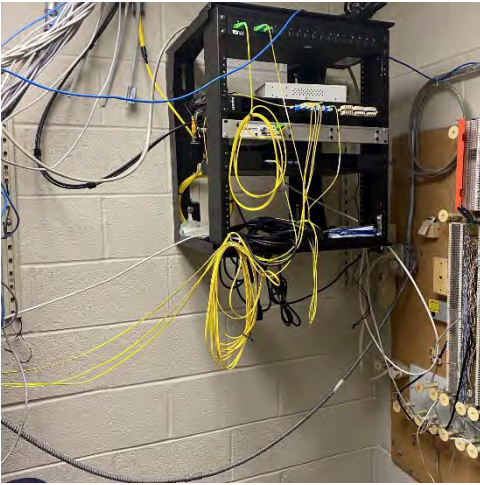
Data Rack

The building has VoIP phone system. The majority of the cables connected to the phones have been run exposed. On most of the floors, in the corridors are the old phone punch down panels that are not in use. None of the cable in the plenum spaces are plenum rated cable. Fire stop material has not been used on the through wall penetrations. Most cable runs coming out of wall, ceilings and floors are not in conduit. It was also

24. Install fire protection for all wall penetration.
25. Complete fixture replacement of all existing exterior and interior lighting with LED fixtures. Lighting selections for each area are to be based on IES recommended foot candle levels and the fixture aesthetics for given locations.

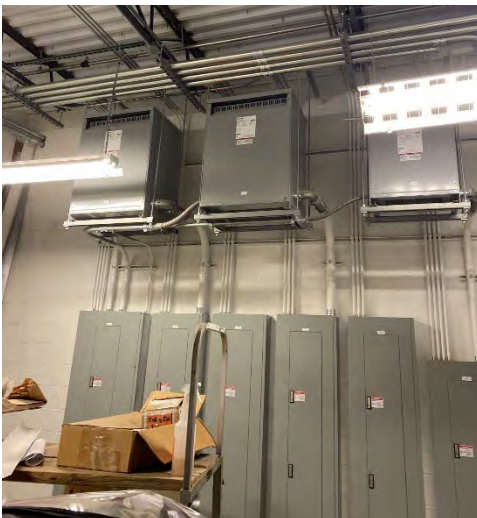
Electrical Panels and Transformers

Electrical/Mechanical room is in excellent condition. Panels have been laid out and installed neatly and efficiently optimizing space. The transformers mounted above the appropriate distanced panels allowing for clean conduit paths connecting the MDP.

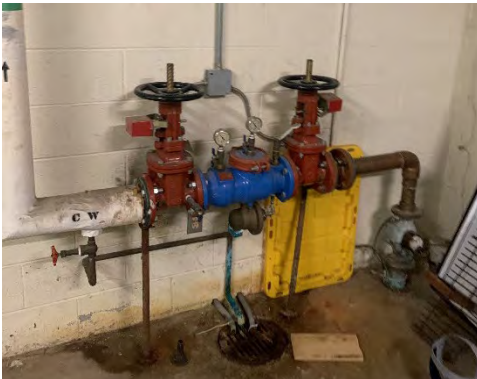
Water Entrance

The main water service to the building provided with a backflow preventer. This backflow preventer has tamper switches on the valves that are tied into the fire alarm control panel. There is a domestic booster pump installed to increase the city water pressure, this system will need to be replaced. Bathrooms were ADA compliant. The toilets were manual flush-valve type and in good condition. The quantity of fixtures was sufficient for the occupants. The domestic hot water system is served by a gas fired instantaneous water heater with a recirculation system. The hot water recirculation loop temperature is maintained by 6-gallon, 2 KW electric water heater. The gas-fired water heater, electric water heater and recirculation pump appeared to be in good condition. This system does not have any thermostatic mixing valves installed.

6. Replace domestic water booster pump.
7. Install sprinkler system to fully sprinkler facility.
8. Install exhaust fan and associated ductwork to exhaust Lab Chemical Prep Room.

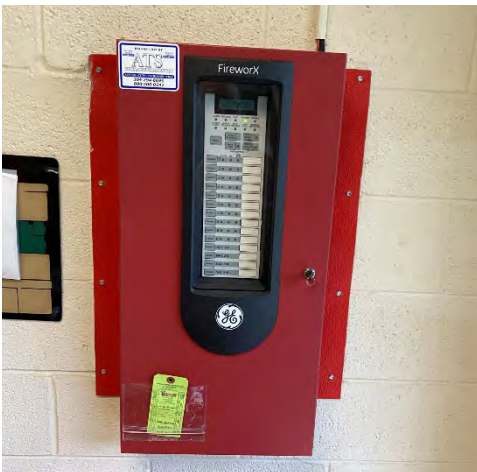
Fire Alarm Control Panel

The main fire alarm control panel is a GE Fireworx with an internal backup battery system. The panel is located in the front foyer and has a building zone map. There are no smoke detectors through the building. Three temporary CO detectors are used to detect gas emissions, one in the common's kitchen sales area, a second in the science classroom and a third in the mechanical/electrical room. There are different styles of horn/strobe and fire alarm pull stations throughout the building. The interior emergency lighting fixtures are recessed tungsten-halogen type. The exterior lighting did not have emergency battery test button thus there were no exterior emergency fixtures noted. There are exit signs located at each exit.

9. Provide smoke detectors.
10. Provide permanent CO detector in needed locations. Hard wired CO detectors with battery backup are recommended in all locations on SWVCTC campuses where gas equipment with open flames are located. The CO detectors should be connected to the fire alarm control panel.

11. Replace older horn/strobe devices.
12. Replace older manual fire alarm pull stations.
13. Emergency lighting for path of egress integral to new lighting for both interior and exterior lighting.

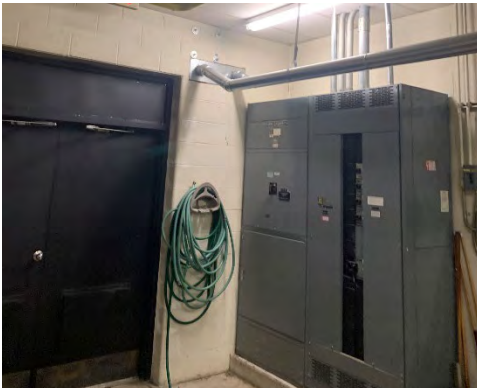
Electrical Power Systems -MDP

The electrical service to the building is fed underground via pole mounted transformers. The electrical service for the building is 480/277V, 3 phase, 4 wire, 600 Amp. The former child development center next to the college also gets their power from this service. The overall condition of the MDP

(Main distribution panel) is in good condition with no notable damage. The panels are not fully labeled for the loads. Damaged floor GFI and code violating receptacles were noted.

16. Create new accurate panel schedules labeling all loads, spare breakers and available space.
17. Replace damaged non code compliant devices and wiring.

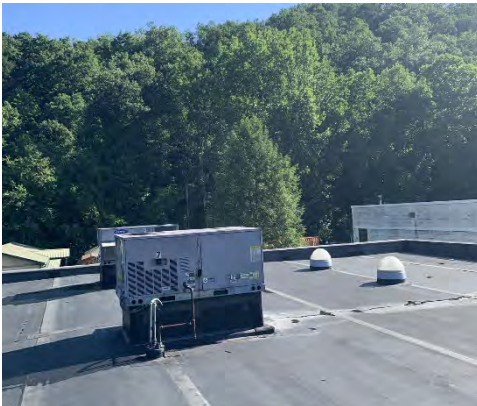
Rooftop Unit

The HVAC system consists of TRANE roof top units (RTUs), zone control dampers in the supply ductwork, and fully ducted return air. The central Building Automation System (BAS) was not provided for major mechanical equipment. All ductwork is provided with external wrap insulation and in several locations was seen to be ripped or not sealed. Fresh, outdoor ventilation air is provided by the RTUs, but outdoor air dampers appeared to have been adjusted or closed because outdoor air intake was minimal. The quantity of supply air zone dampers provides fair controllability for the classrooms, but office spaces often have complaints.

3. Remove cracked floor tiles and evaluate the underlying concrete slab.
4. Budget for the replacement of the existing major equipment - Roof Top Units and Exhaust Fans.

5. Provide a central Building Automation System as the RTUs are replaced.
6. Investigate the hot water recirculation pump and piping, determine operational issues, and recommission or replace.

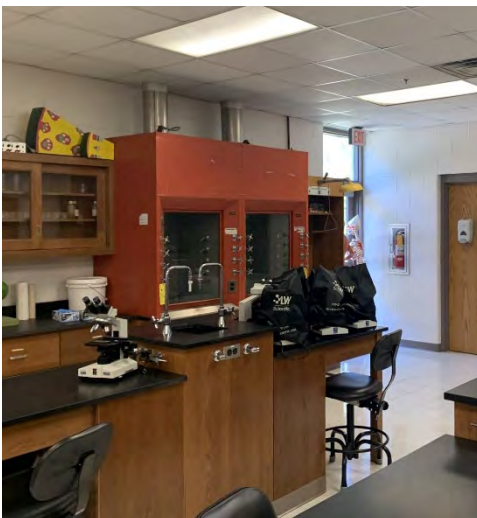
Fume Hood

The two (2) chemical containment exhaust hoods located in the front Science Lab had up-to-date inspection/approval stickers. The Science Lab chemical storage rooms did not appear to have proper exhaust and ventilation. Automatic gas shut-off valves were installed in the correct location. The RTUs were installed in 1997 and appear to be reaching the end of their expected service life (15-20 years). The Science Lab exhaust fans for the containment hoods also appear to be reaching the end of their service life.

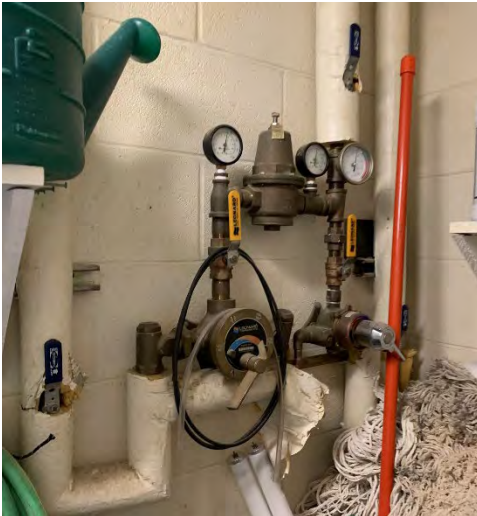
Thermostatic Mixing Valve

The hot water recirculation pump was not running. The entire hot water recirculation system has not been operating correctly for some time. A thermostatic mixing valve was located in the custodian closet. Toilet rooms appeared to be ADA compliant and provided with flush valve fixtures. The quantity of toilet fixtures is sufficient for the building classification and the fixtures appeared to be in decent condition. A mop sink was located in the custodian room. There were several water fountains provided, operational and appeared to be in good condition. There appeared to be a leak from one of the roof drains and/or storm piping in Classroom 119. There is an overflow roof drain installed above an exterior light.

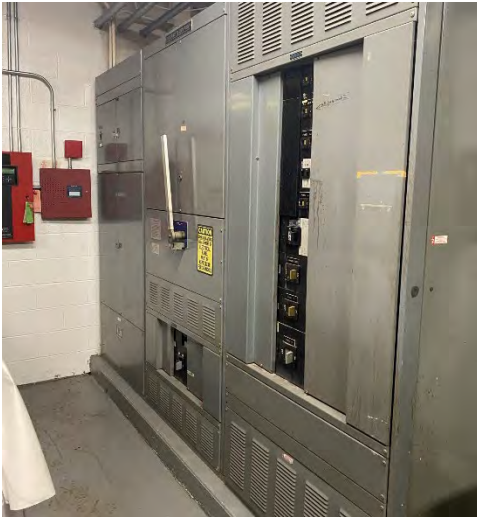
Electrical Power Systems - MDP

The electrical service for the whole building is fed underground via a pad mounted transformer, to the service meter located in the Boone Career Technical Center's Mechanical Room 11. The overall condition of the MDP (Main distribution panel) is in fair condition with no notable damage. The electrical distribution for the Southern CTC side of the building is in good condition than the older MDP. These panels contain spares and blank space available for future loads. The panels are not fully labeled for the loads that are on them. A complete load assessment per panel and per circuit is required to determine the adequacy of the electric service shared throughout the buildings three schools.

Some locations were noted to have exposed wiring and improper wire connections. Damaged floor receptacles and audio equipment ports corroded electrical raceways and wall penetration without fire protection were also noted.

10. Create new accurate panel schedule labeling all loads, with spare breakers and available space.
11. Replace damaged wiring, exposed and M/C wiring with correct sized wire in conduit.

12. Replace damaged and corroded raceways.
13. Install fire protection for all wall penetration.
14. Damaged floor receptacles need to be replaced or removed and patched.

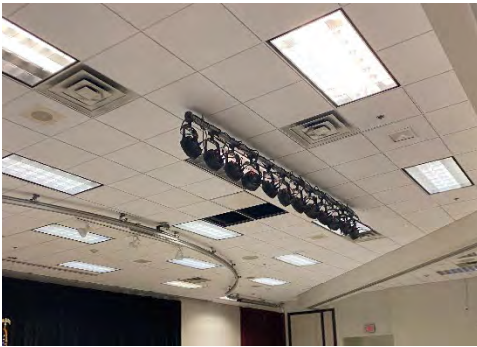
Egg Crate Lighting Fixtures

The exterior lighting for the building consists of large wall mounted metal halide fixtures that are used for area and walkway lighting. Recessed metal halide fixtures are used at the entrance. The exterior lighting is controlled by mechanical time switches. The offices and main classroom have 2x4 T8 recessed egg crate fixtures. The corridors, main entrance and some classrooms have 2x4 T12 recessed troffers. Most of these troffers have yellow stained parabolic lens. The commons area lighting has both suspended indirect fixtures and recessed fixtures both lamped with metal halide bulbs.

15. Undertake a complete fixture replacement of all existing interior and exterior lighting with LED fixtures excluding stage LED lighting in the large lecture room 110. Lighting selections for each area are to be based on IES recommended foot candle levels and the fixture aesthetics for given locations.

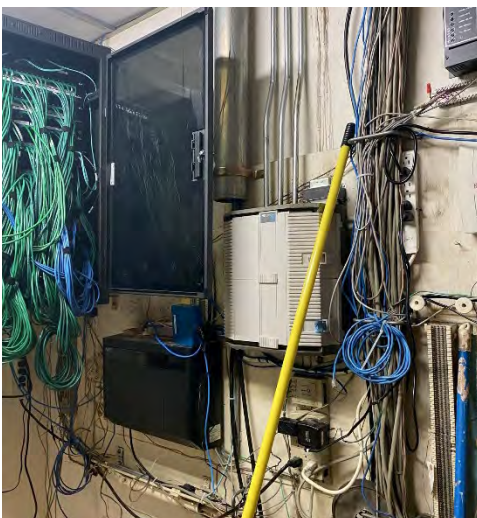
Data / Communications Cabling

The data and communications systems are on a shared service for the whole building. The data and communications come into and are distributed from a room just off from the Boone Career Technical Center's Mechanical Room 11. The room is only cooled by one small window style air conditioning unit. Transformers and electrical panels are also located in these rooms. The wire management for the data and communications in this room is in poor condition. The overall space for the data and communications distribution systems is cluttered. The portable wheel-based cabinets are placed in front of each other. The power supplies for these cabinets are lying on the floor.

The phone system is a VoIP Cisco system. For all the phone locations, the cables are direct CAT5e drops from the ceiling running exposed to the Cisco phones. Some data drops in the front office in the Science Lab are also drops from the ceiling running exposed in the space. The majority of this cabling is not plenum rated and penetrations are not fire stopped.

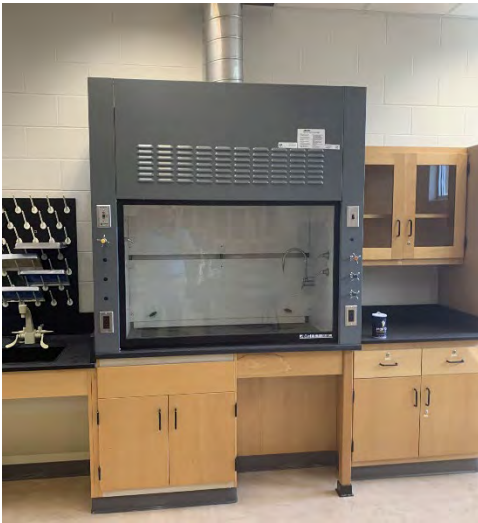
Fume Hood

There was a chemical containment exhaust hood located in the Physics/Chemistry Lab that did not have an up-to-date inspection/approval sticker on it. There is a return air plenum utilized throughout the facility, everything located within the plenum appeared to be plenum rated and compliant. Proper exhaust airflow was provided to all toilet rooms, Janitor closets and Labs. Adequate fire dampers, and fire caulking was observed for penetrations through fire-rated walls. The occupancy schedules for the entire facility and central plant equipment operation are controlled by the main Building Automation System (BAS) located in the High School. Therefore, HVAC issues arise when the SWVCTC is using their facilities and the High School is not. The building was constructed in 2004 and all of the mechanical equipment is operational and in good condition. Maintenance is performed by the Lincoln County High School maintenance personnel.
